# Aviation Investigation Final Report

| <b>Location:</b> | Portland, Arkansas | <b>Accident Number:</b> | ERA22FA338 |
| <b>Date &amp; Time:</b> | July 26, 2022, 17:01 Local | <b>Registration:</b> | N749LA (A1); N214RL (A2) |
| <b>Defining Event:</b> | Midair collision | <b>Injuries:</b> | 1 Fatal (A1); 1 Serious (A2) |

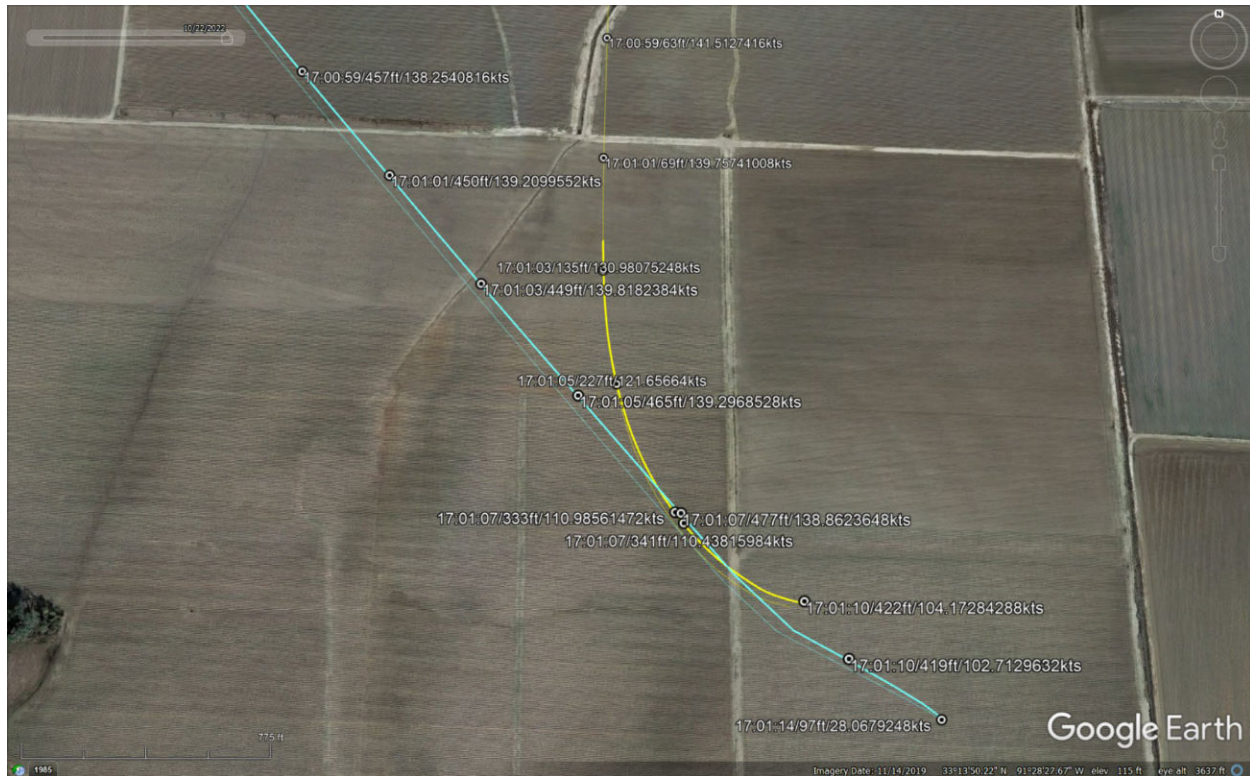
Based on the relative positions of both airplanes, as the AT-802A was on its southwesterly heading, the AT-802 would have been located at the pilot's approximate 1 o'clock position. Simultaneously, about 45 seconds before the collision, as the AT-802 was flying on the southeasterly heading, the AT-802A would have been positioned at the pilot's approximate 10 o'clock position. Just before the collision (1701:07), the AT-802 indicated 477 ft altitude and about 139 knots ground speed, while the AT-802A indicated 341 ft altitude and 110 knots ground speed. The data indicated that the AT-802A was in a climbing, left turn at the time of impact, while the AT-802 was flying relatively straight and level (see figure 1).

Figure 1: Track of the AT-802 (214RL, Cyan) and the AT-802A (N749LA, Yellow). Approximate location of collision is where the lines converged.
